Installer: Ram Jack of Tennessee • 866 735-3085

Situation:

Solution:

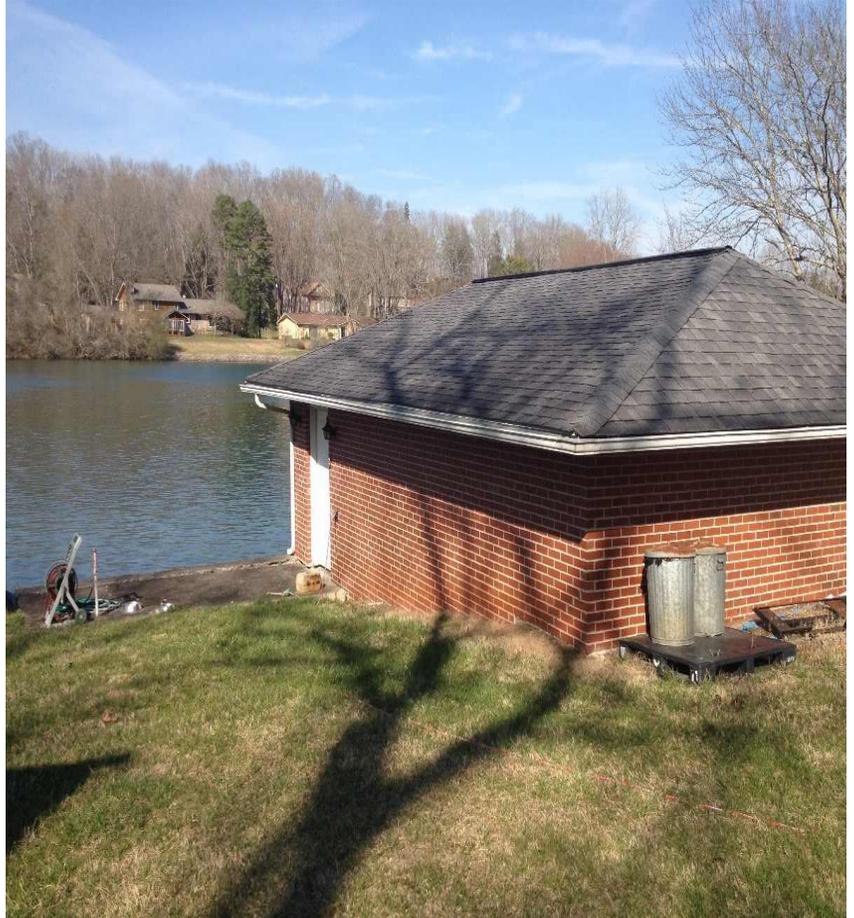
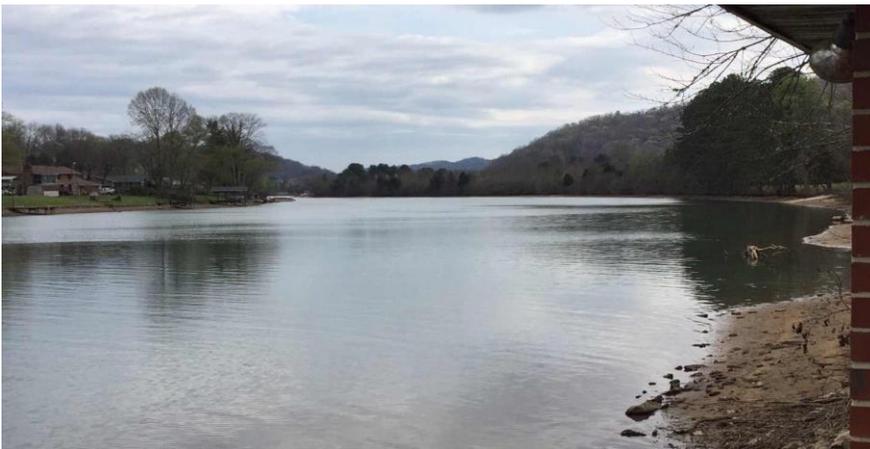
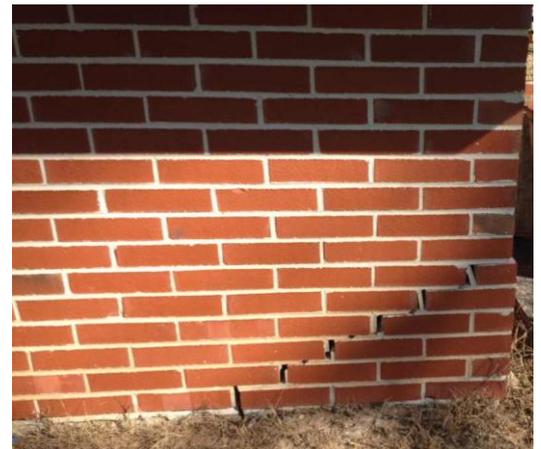
Ram Jack of Tennessee was contacted in early March 2016 by the owner of a boathouse presenting significant signs of foundation and structural distress. The boat house was constructed in such a manner as to place only the wall and roof loads on the footer while the boat, boatlift, and other live loads were supported by a separate foundation system. Complicating the remediation was the very short window in which the TVA would be lowering the water level in the lake. This several day period would expose a portion of the building footer and provide the only reasonable window for pile installation.

Ram Jack consultants developed a repair plan to make use of thirteen (13) helical piles with a two-flight design of 8” and 10” helices on a 2 7/8 pile shaft. The design included the use of an external steel guide sleeve and “side-load” type footer brackets. The piling plan was approved with the ambiguous installation window as the only unknown.

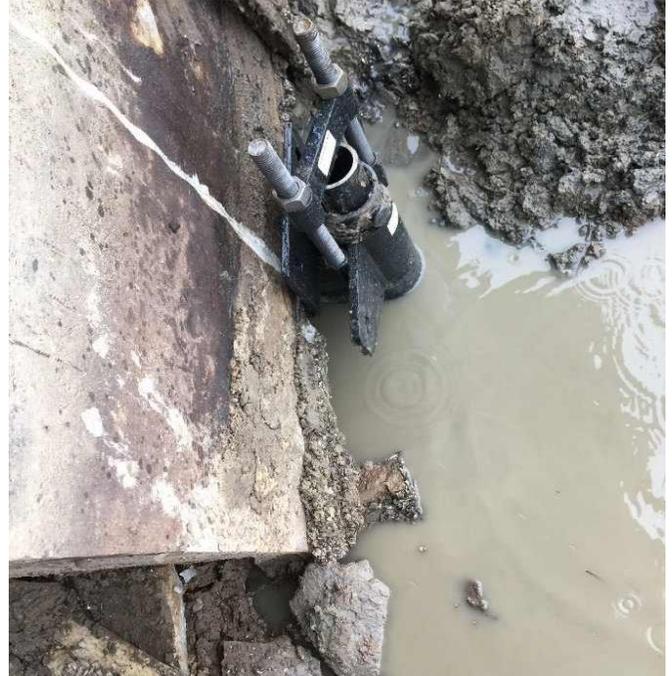
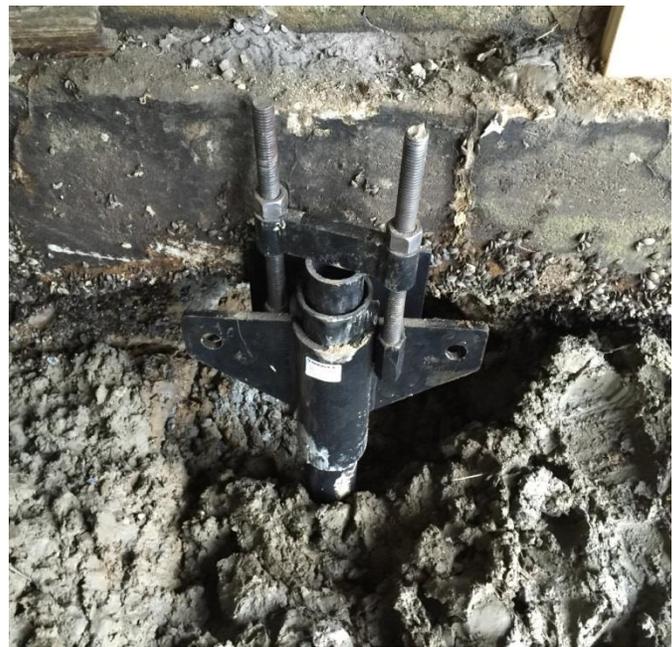
The water in Lake Melton Hill was lowered over a several day period ending on March 22, 2016. Ram Jack installation technicians arrived on-site early the next day and completed installation two days later. The helical piles were driven to an average depth of just over 20’ where they reached a target installation torque of 2,500 lb/ft. The hydraulic systems were then synchronized to achieve maximum practical recovery of the structure and the brackets secured to permanently underpin the structure. The water level was allowed to return to its normal level several days later and the boat lift and boathouse returned to their operational state with a strong and stable foundation ensuring many additional years of trouble free service.
