## Model 150 Helical Tiebacks

**Project:** Historic Home Tiebacks

**Location:** Davenport, IA

**Date:** May 2012

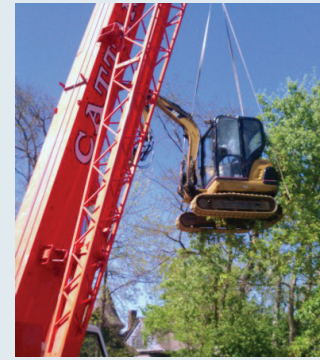
Lowering mini-excavator onto working surface below wall

Helical tiebacks were selected to stabilize the sheet pile wall, with an original design including three rows of tiebacks with a design working tension load of 21 kips each. A crane lowered a mini-excavator onto the temporary working surface and openings were torch-cut in the sheet pile wall at each anchor location. As the first tieback of the upper row was advanced, an obstruction was encountered at a length of approximately eight feet from the wall. The soils were excavated between the home and the retaining wall, exposing unexpected concrete underpinning beneath the existing foundation. This discovery prompted a redesign of the project, including eliminating a row of tiebacks, decreasing the tieback spacing, and coring holes through the existing concrete underpinning to allow for the installation of the tiebacks. The final tieback design included twenty-four Model 150 (1.5-inch round corner square bar) helical tiebacks with 12"-14" helix plate configurations. The tiebacks were generally positioned in rows six feet and 13 feet below the top of the sheet pile wall, spaced approximately five to six feet apart, and installed at a downward angle of 20 degrees. The tiebacks were advanced to lengths of 12 feet (bottom row) to 35 feet (top row) behind the wall and to installation torque values correlating to ultimate capacities of at least two times the design working load of 21 kips ( $FOS \geq 2$ ). Pieces of the sheetpile wall cut out to allow tieback installation were modified to fit over the tieback and then welded back in place. A waler system consisting of two C6x13 steel channels was installed to distribute the tieback forces evenly across the sheetpile wall. The tiebacks were pre-tensioned to the design working load with a calibrated hollow-core hydraulic cylinder. Despite the challenging working conditions and unforeseen obstructions, the tiebacks were installed and the sheet pile wall stabilized in nine days.

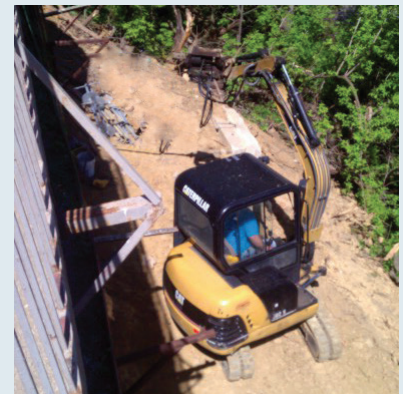
Maneuvering for tieback installation

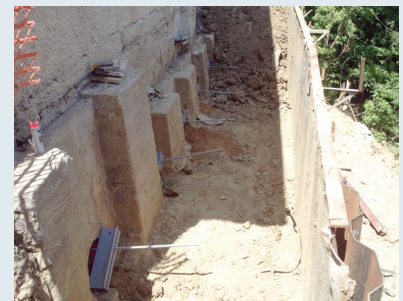
Tiebacks advanced through core holes of concrete underpinning

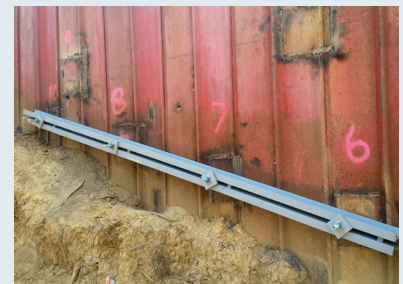
Waler detail

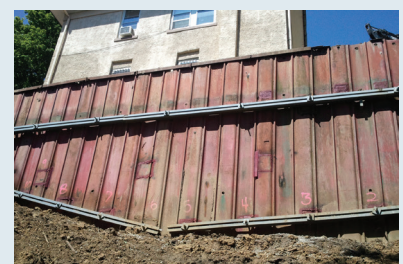
Tieback and waler installation complete
