**DANBRO CASE HISTORY:
FUTURE REPAIR OF RETAINING WALL AND OUTFLOW BROOK
HOPE & MEAD STREET
STAMFORD, CT**

CONTE COMPANY, LLC

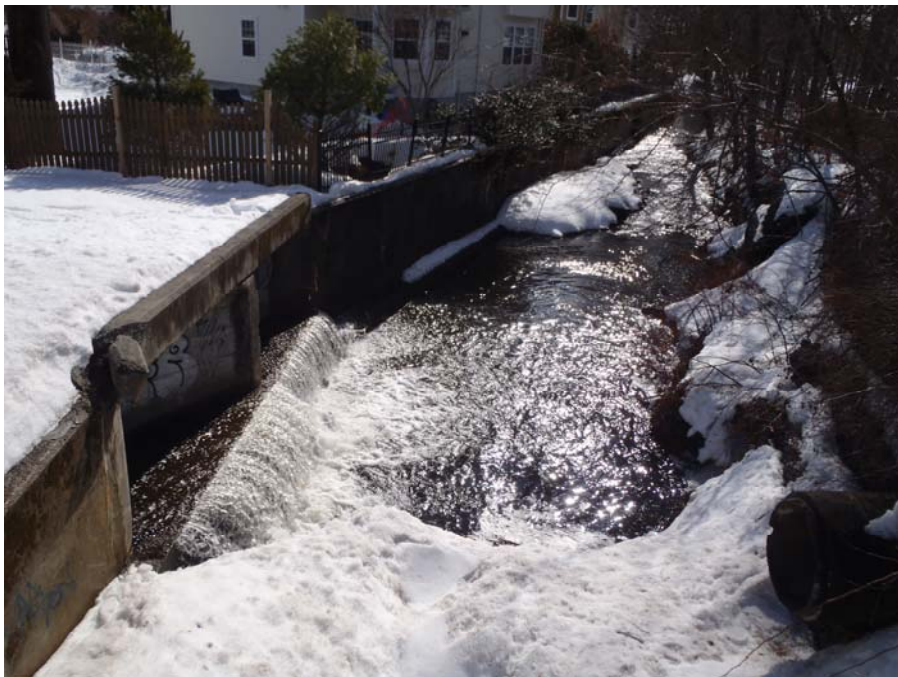
THE MOUTH OF A MUNICIPAL DRAINAGE CULVERT EMPTIED INTO A RIVER ADJACENT TO A RESIDENTIAL COMPLEX. THE EROSION FROM THE LARGER STORM RUNOFF HAD SCOURED THE SOIL AND UNDERMINED THE RETAINING WALL PROTECTING THE FOUNDATIONS OF THE RESIDENTIAL COMPLEX. THE CITY OF STAMFORD WAS ASKED TO ADDRESS THIS ISSUE AND REQUESTED 26 HELICAL PILES BE INSTALLED AROUND THE RETAINING WALL FOOTING. THE DESIGN HAD YET TO BE COMPLETED, BUT THE INFORMATION FROM PREVIOUS TEST PILES HAD GIVEN THEM ENOUGH TO PLACE ANCHORS AS NEEDED. THE PILES WERE PLACED THROUGHOUT THE RIVERBED AND INSIDE THE RESIDENTIAL COMPLEX.

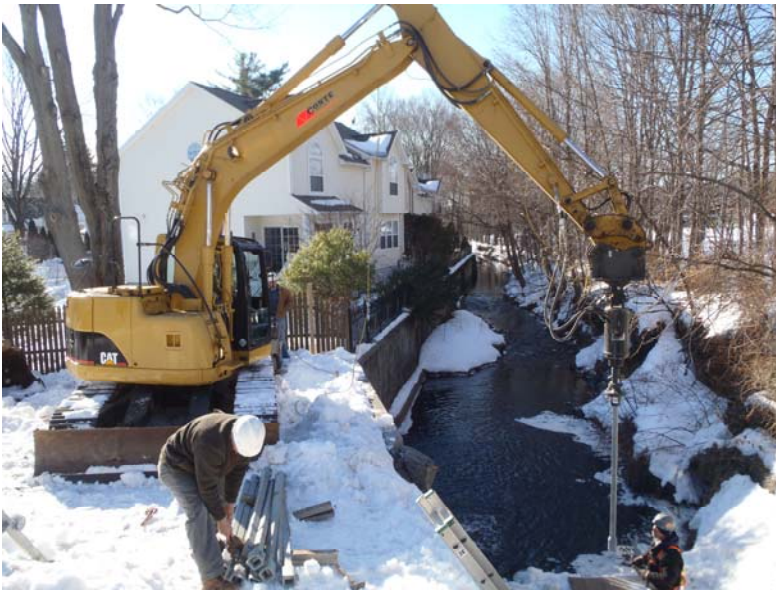
CHANCE HELICAL SOLUTIONS:
THE SOIL HAD BEEN ASSUMED TO CONSIST OF HEAVY COBBLES AND DENSE SAND. THE SS225 WAS USED TO WITHSTAND THE POSSIBLE OBSTRUCTIONS AND HEAVY TORQUES. ACCESS WOULD NOT ALLOW ANY EQUIPMENT FOR DRIVEN PILES.

- # OF PILES = 26
- SS225 WITH 8", 10" & 12"

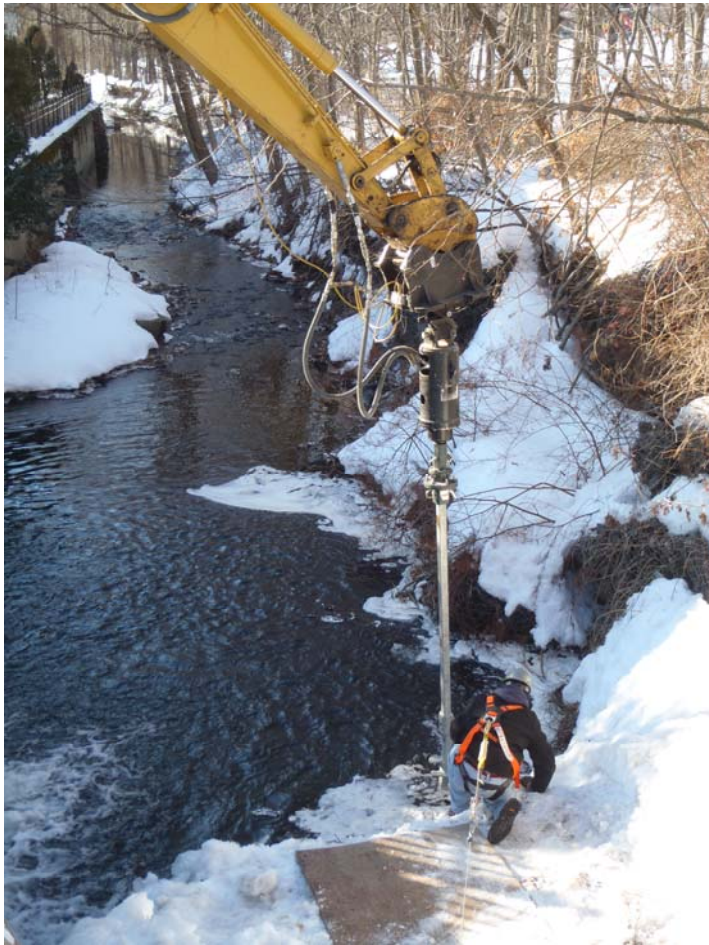
TERRAIN AND TREE OBSTRUCTIONS REQUIRED THE USE OF A TIGHT-TURNING RADIUS EXCAVATOR THAT COULD TRAVERSE THE RIVERBED. ACCESS HAD BEEN MADE WITH A RAMP INTO THE RIVER AND ALL EQUIPMENT WAS CARRIED TO LOCATION BY THE EXCAVATOR BUCKET. ALL TORQUE MONITORING EQUIPMENT WAS STRAPPED TO THE BACK OF THE EXCAVATOR TO KEEP IT MOBILE AND OUT OF THE RIVER WATER. THE MEN USED A SMALL PLATFORM TO FLOAT ALONG THE DEEP AREAS AND ADD EXTENSIONS DURING INSTALLATION.
